Good Engineering Practices in a Lift System

by PVN Marar

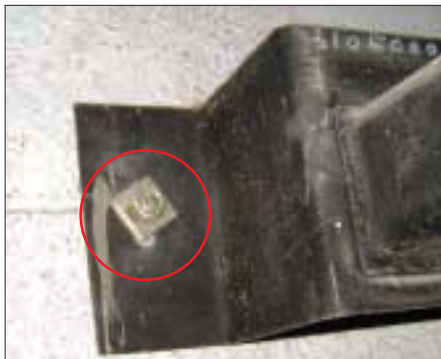
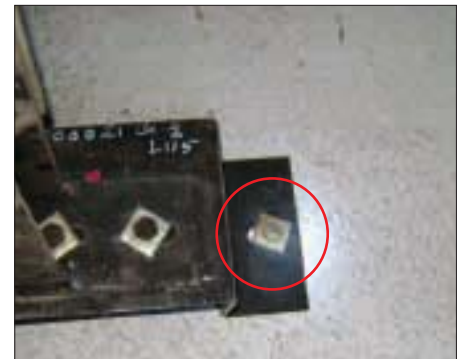
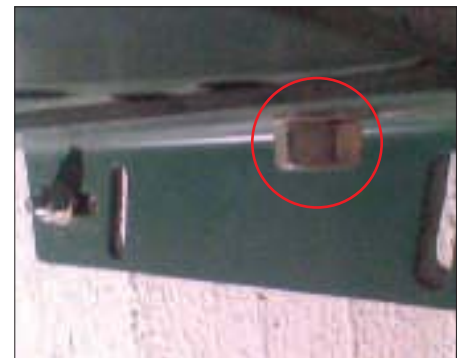
In a normal concrete structure, the connection of rail brackets with shaft walls is done by using dash fasteners or expanding bolts. It is observed, that in certain installations, a fastener nut has a bearing of two threads on bolt, instead of the right way in which the bolt thread extends from the nut, and, at the same time, the bolt shall

Examples of bolts improperly installed

have the specified penetration. This may be seen as a small overlooked but major concern, as the brackets that support the entire rail-guiding system may get detached from the structure if the nut gives way due to vibration. While all of the detailed design calculations prove otherwise, a minimum of two full threads of bolt must extend from nut after giving the required torque; this would be a GEP.

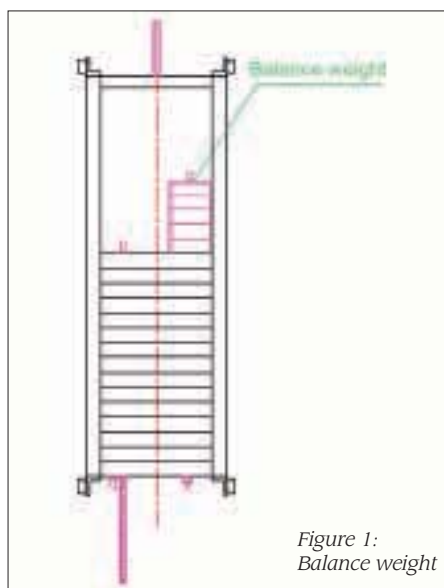
Figure 1:
Balance weight

or whisper-flex between 250 to 300 kg in weight, depending on the construction and type of hoist rope – enough to imbalance a counterweight frame. This increases when the car travels down. The problem can be eliminated if the compensating chain is installed at the center to balance the entire frame and thus avoid abnormal wear and tear of the guiding systems. The only extra requirement in this arrangement is to have two buffers instead of one. Alternatively, a small size weight (Figure 1) can be added on the normal weight at the opposite side of a compensation chain. Also, a specially designed filler weight (Figure 2) can be used for balancing. However, both arrangements will be inclusive of the total counterbalance weights. Unfortunately, the static balance of counterweight is seldom looked at seriously.

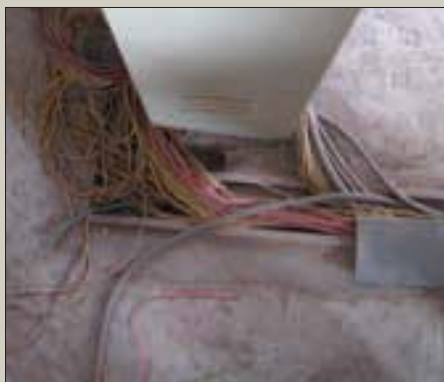
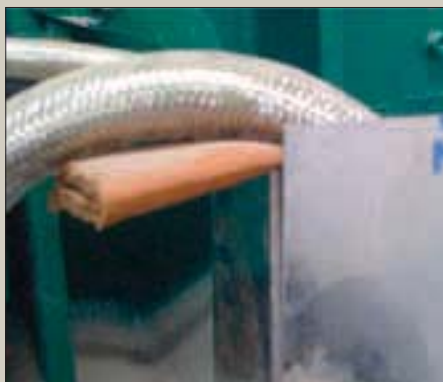
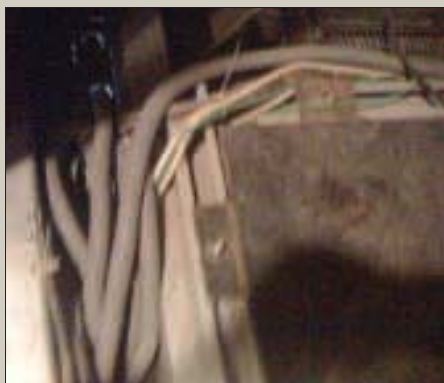
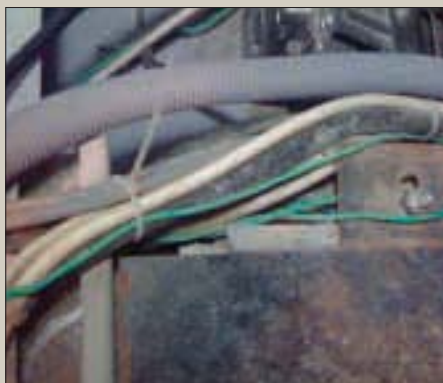
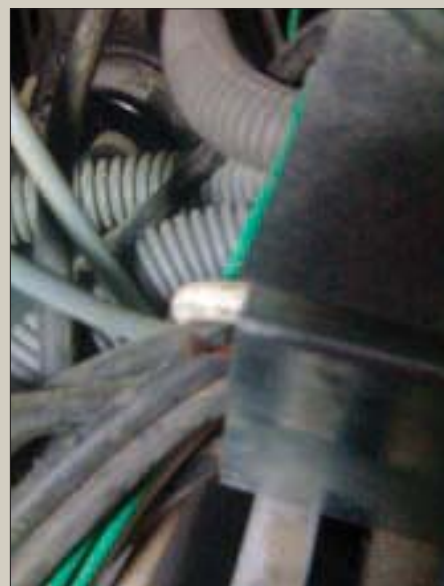
Wiring done imperfectly

The electrical wiring in an elevator system needs to be concealed or encased by the means of a trough, conduits, flexible pipes and trays. A live wire cannot be left open without protection and the neat dress up of wires and cables is very important. The photographs are self explanatory and indicative for quality analyzes.

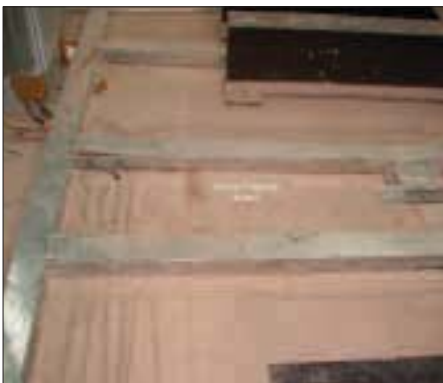
In some of the installations, a machine-room trough is fixed on the floor surface, not embedded, to get them flush with floor. The result is a tripping hazard.

Machine-room trough – a serious tripping hazard
